FIELD TESTS OF THE CUCARACHA FORMATION, PANAMA CANAL, 1942-1946

C. K. Smith, R. J. Lutton

May 1974

Conducted by U. S. Army Engineer Waterways Experiment Station
Soils and Pavements Laboratory
Vicksburg, Mississippi

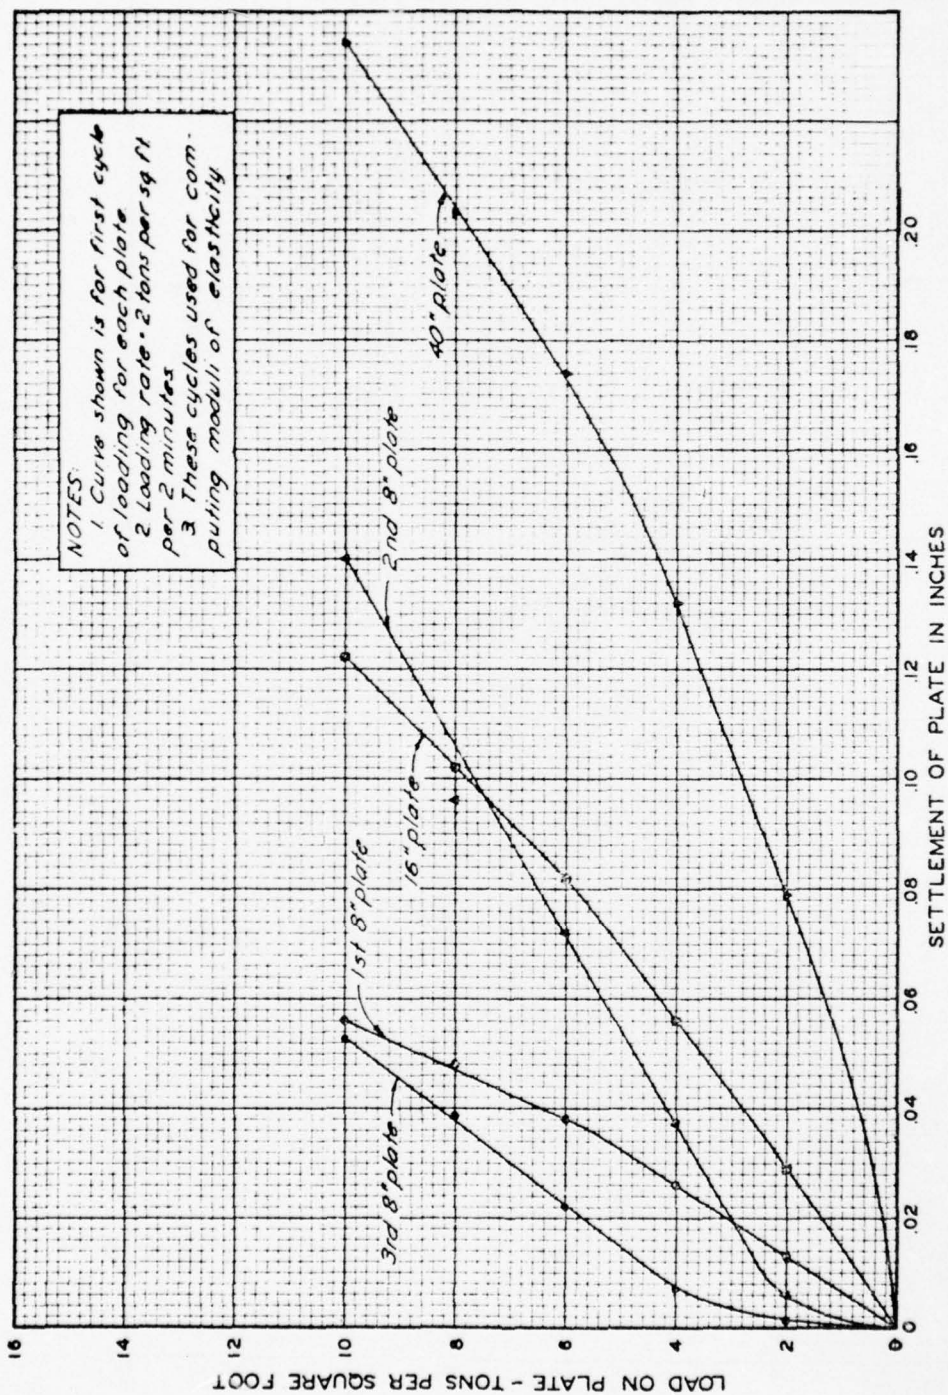
Fig. 21. Load versus settlement, first loading cycle for all field plate bearing tests, Pedro Miguel Test Pit No. 3

71. A total of five bearing tests on circular plates were performed in the field. Tables 2 and 3 are summaries of the results of these tests. Figs. 14-21 show the load versus settlement curves, and figs. 22-27 show the time versus settlement curves.

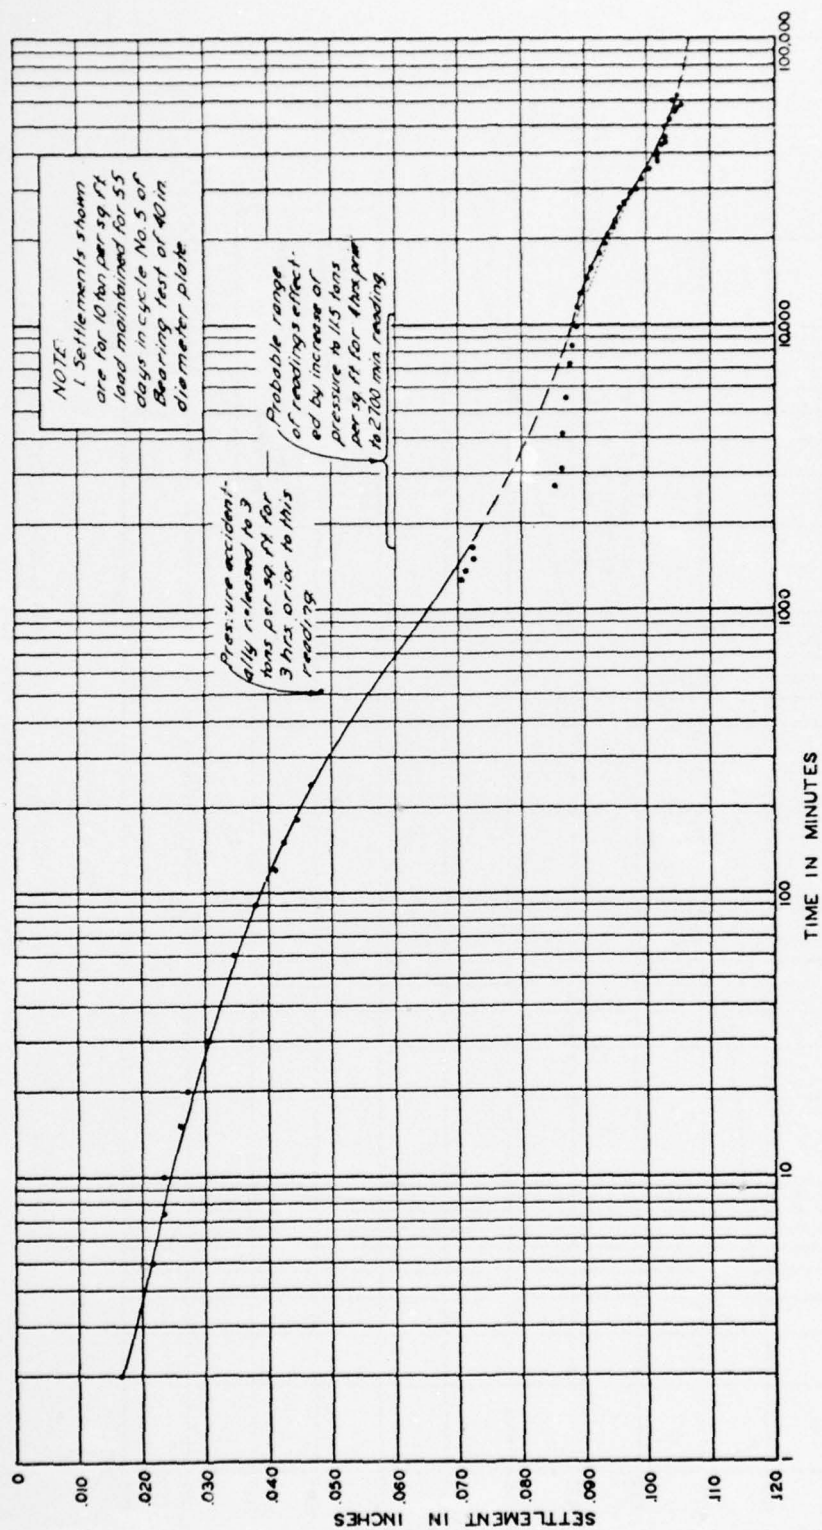
Fig. 22. Time-settlement curve, 40-in.-diam plate bearing test, Pedro Miguel Test Pit No. 3

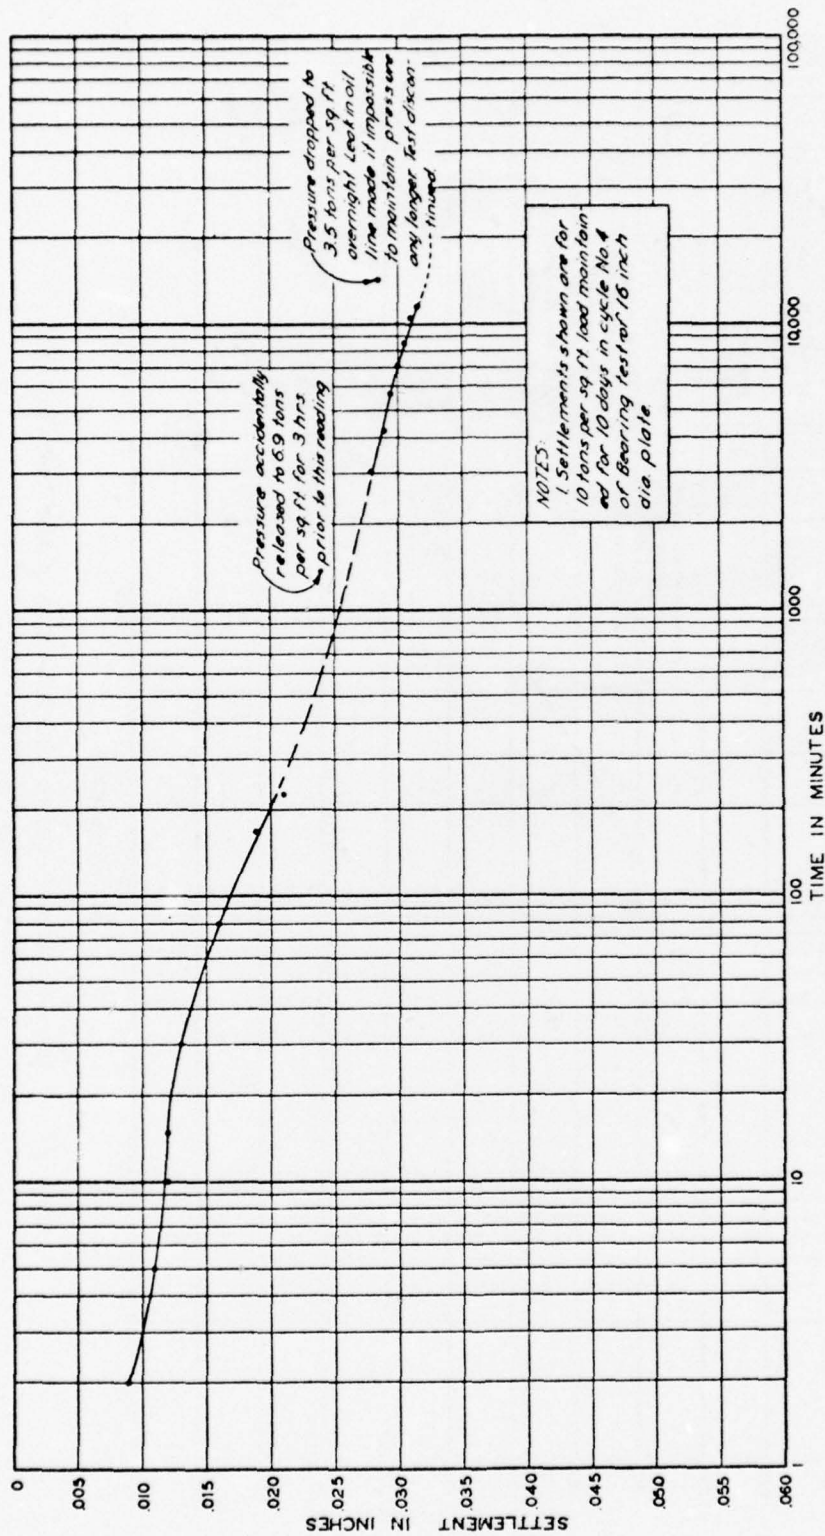
Fig. 23. Time-settlement curve, 16-in.-diam plate bearing test, Pedro Miguel Test Pit No. 3

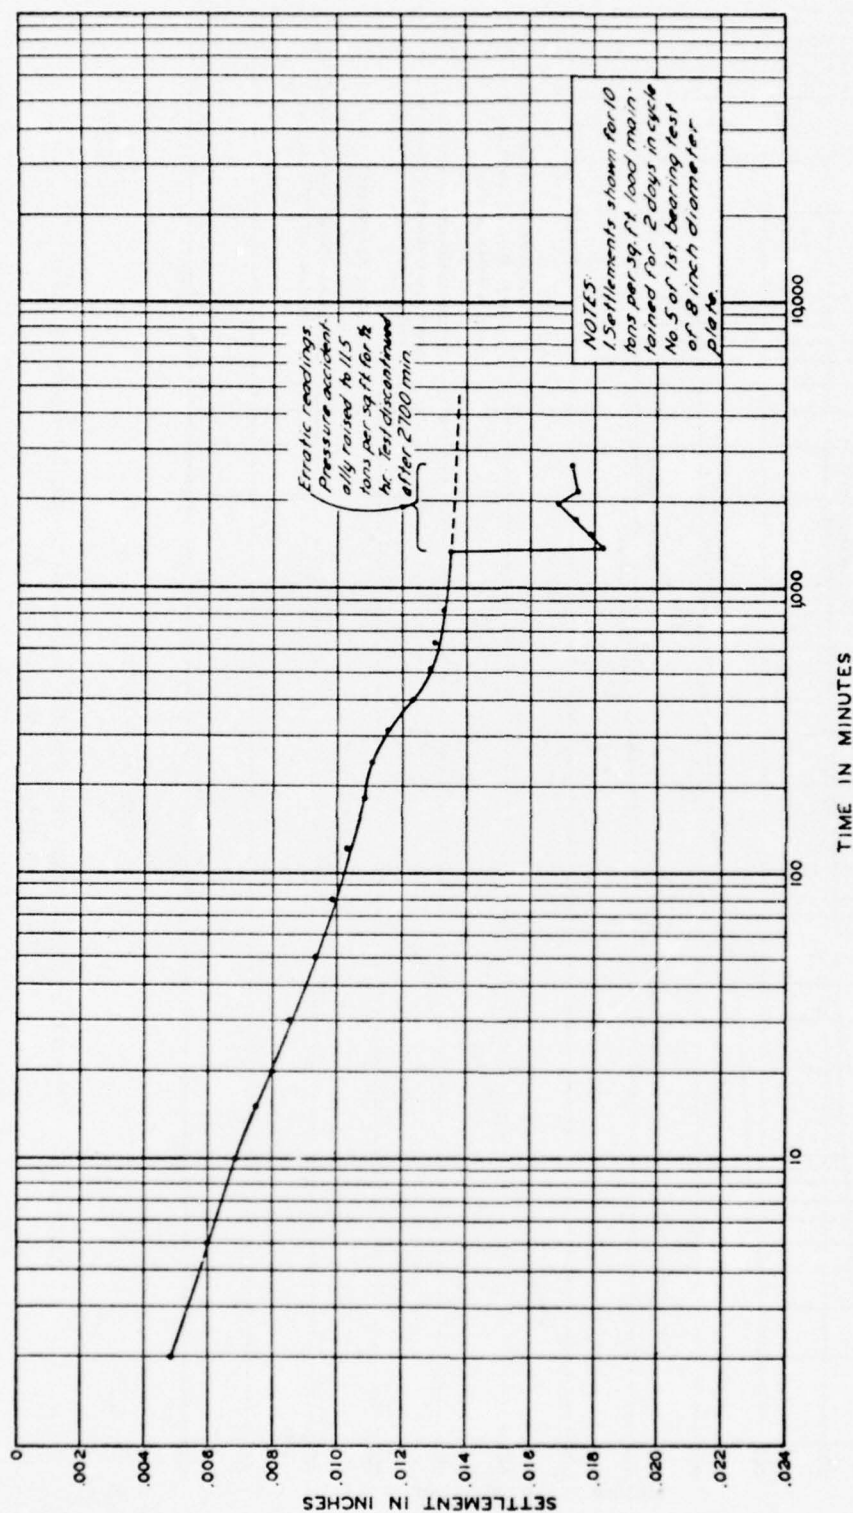
Fig. 24. Time-settlement curve, first 8-in.-diam plate bearing test,
Pedro Miguel Test Pit No. 3

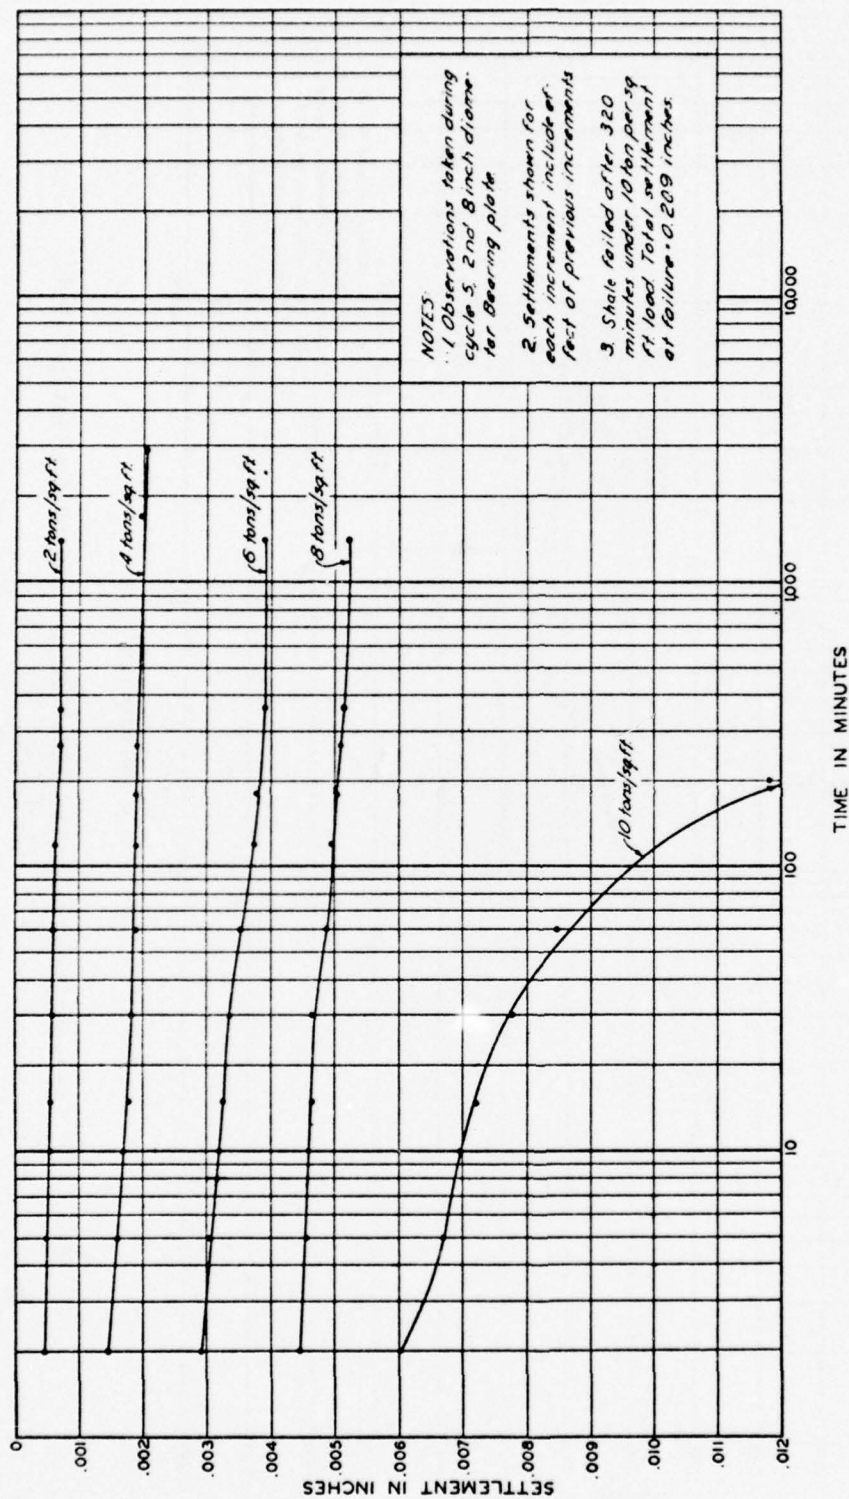
Fig. 25. Time-settlement curves, second 8-in.-diam plate bearing test, Pedro Miguel Test Pit No. 3

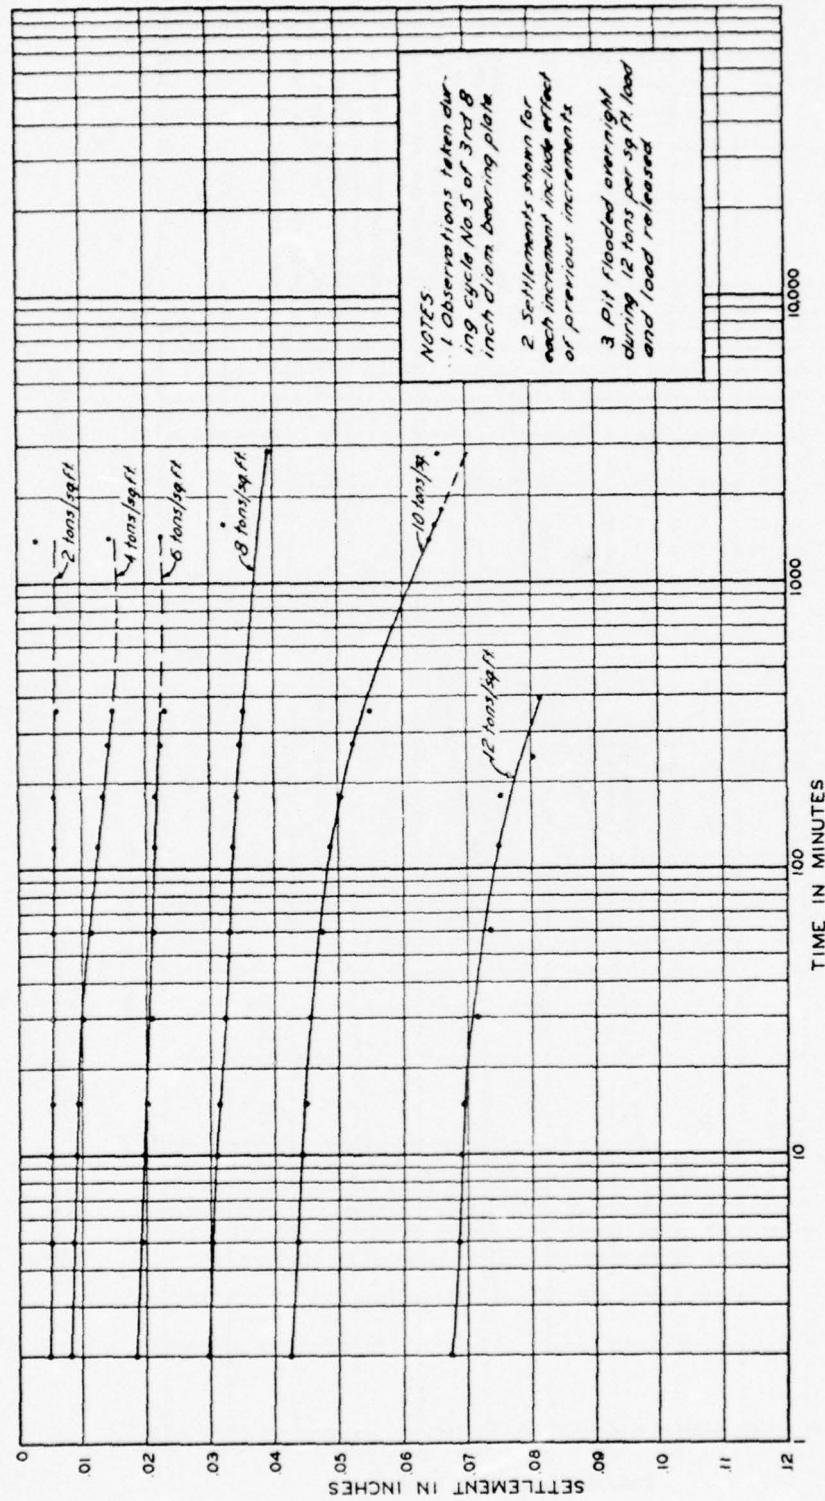
Fig. 26. Time-settlement curves, third 8-in.-diam plate bearing test (cycle 5), Pedro Miguel Test Pit No. 3

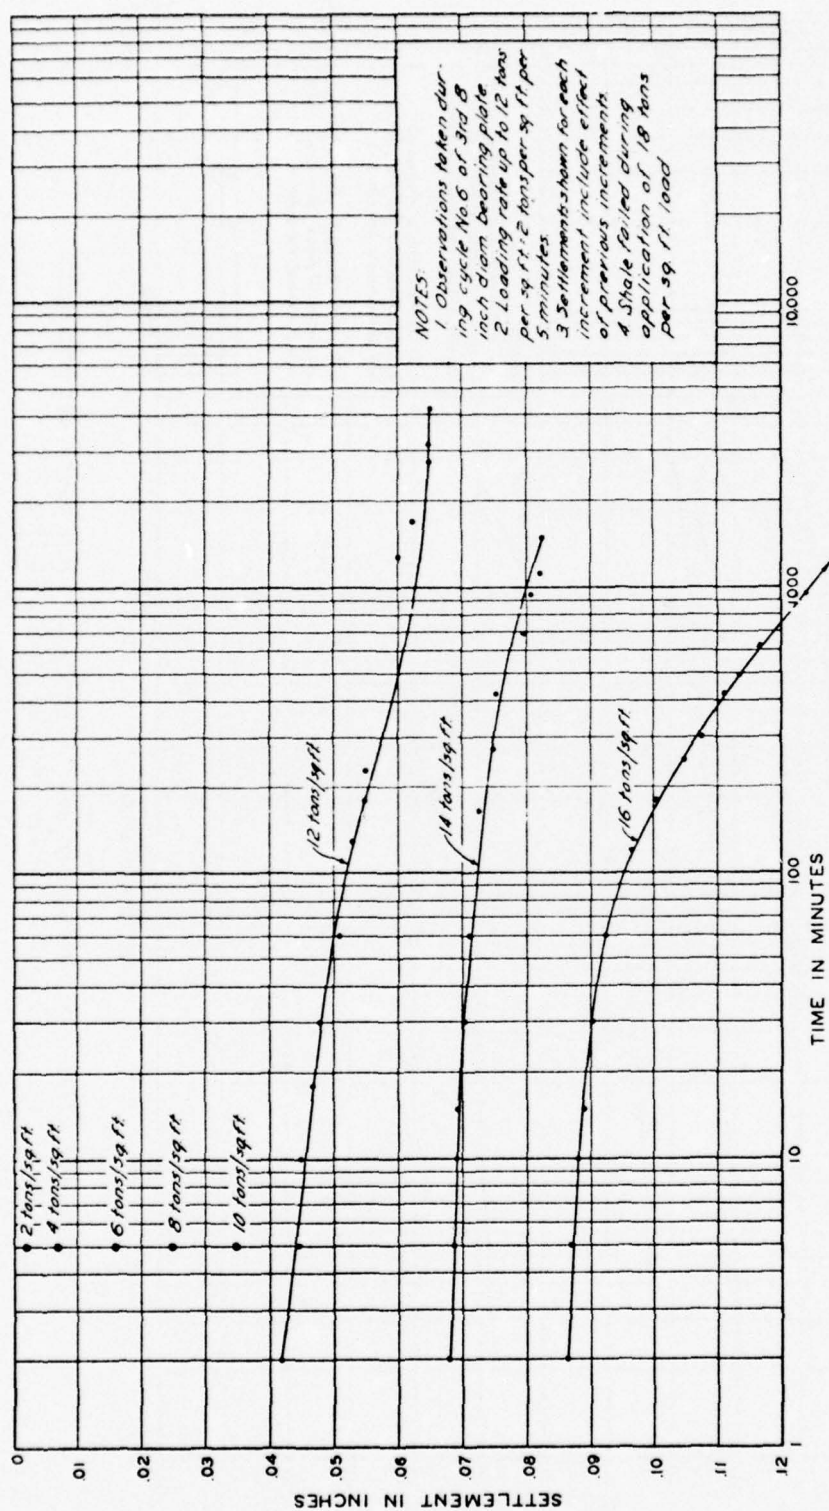
Fig. 27. Time-settlement curves, third 8-in.-diam plate bearing test (cycle 6), Pedro Miguel Test Pit No. 3

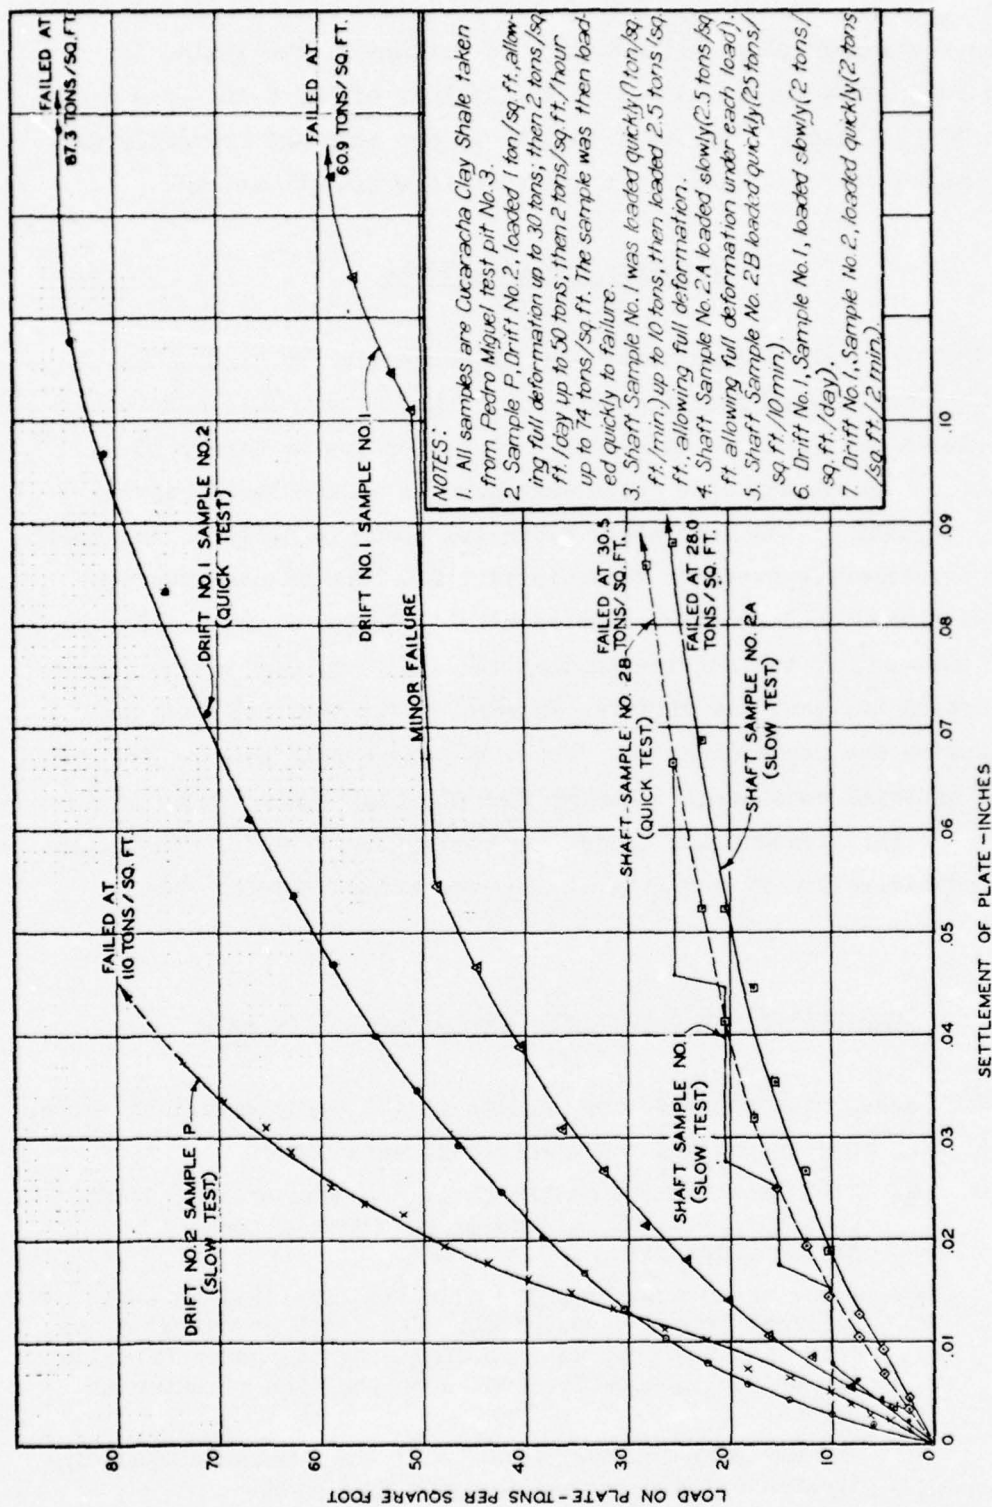
Fig. 28. Load versus settlement, laboratory plate bearing tests, Pedro Miguel Test Pit No. 3

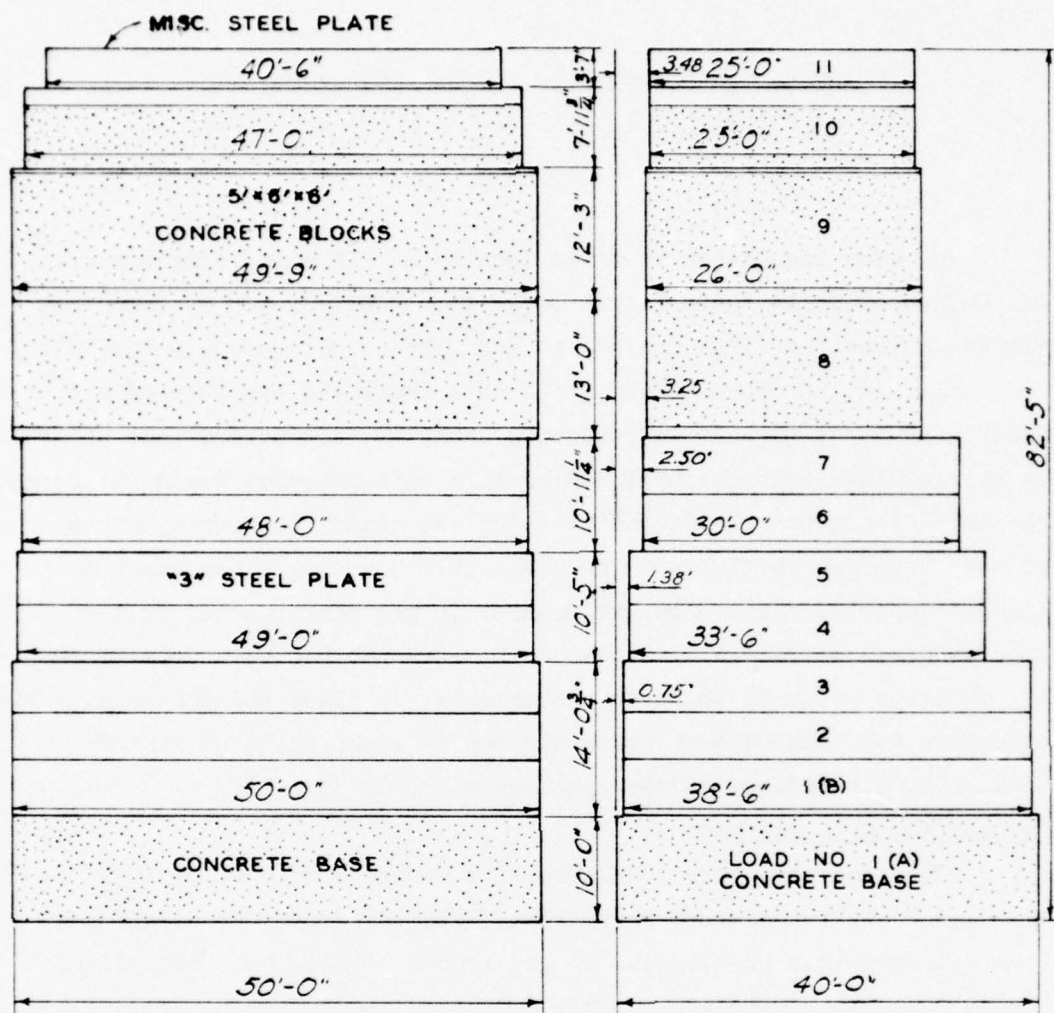
ACCUMULATIVE BASE LOAD
KIPS PER SQ. FT

LOAD NO.	TOE LOAD	HEEL LOAD	DATE STARTED	DATE COMPLETED
1 (A)	1.50	1.50	2-14-44	3-7-44
1 (B)	3.91	3.91	3-14-44	3-22-44
2	5.95	5.95	3-29-44	4-3-44
3	8.00	8.00	4-10-44	4-13-44
4	10.56	9.44	5-24-44	5-30-44
5	13.12	10.88	6-5-44	6-9-44
6	15.67	12.04	10-2-44	10-5-44
7	18.21	13.20	10-17-44	10-19-44
8	20.31	13.78	11-3-44	11-7-44
9	21.92	14.23	11-16-44	11-17-44
10	23.51	14.63	11-29-44	12-2-44
11	25.00	15.00	12-12-44	12-16-44

78. Loads were applied uniformly until a theoretical unit foundation pressure of 4 tsf was obtained. The remainder of the load was applied so that the final load produced a theoretical straight-line distribution of base pressure ranging from 7.5 tsf along the east side to 12.5 tsf along the west side of the structure. Unit loads of 4 and 6 tsf were chosen for specific observation of long-time settlement because

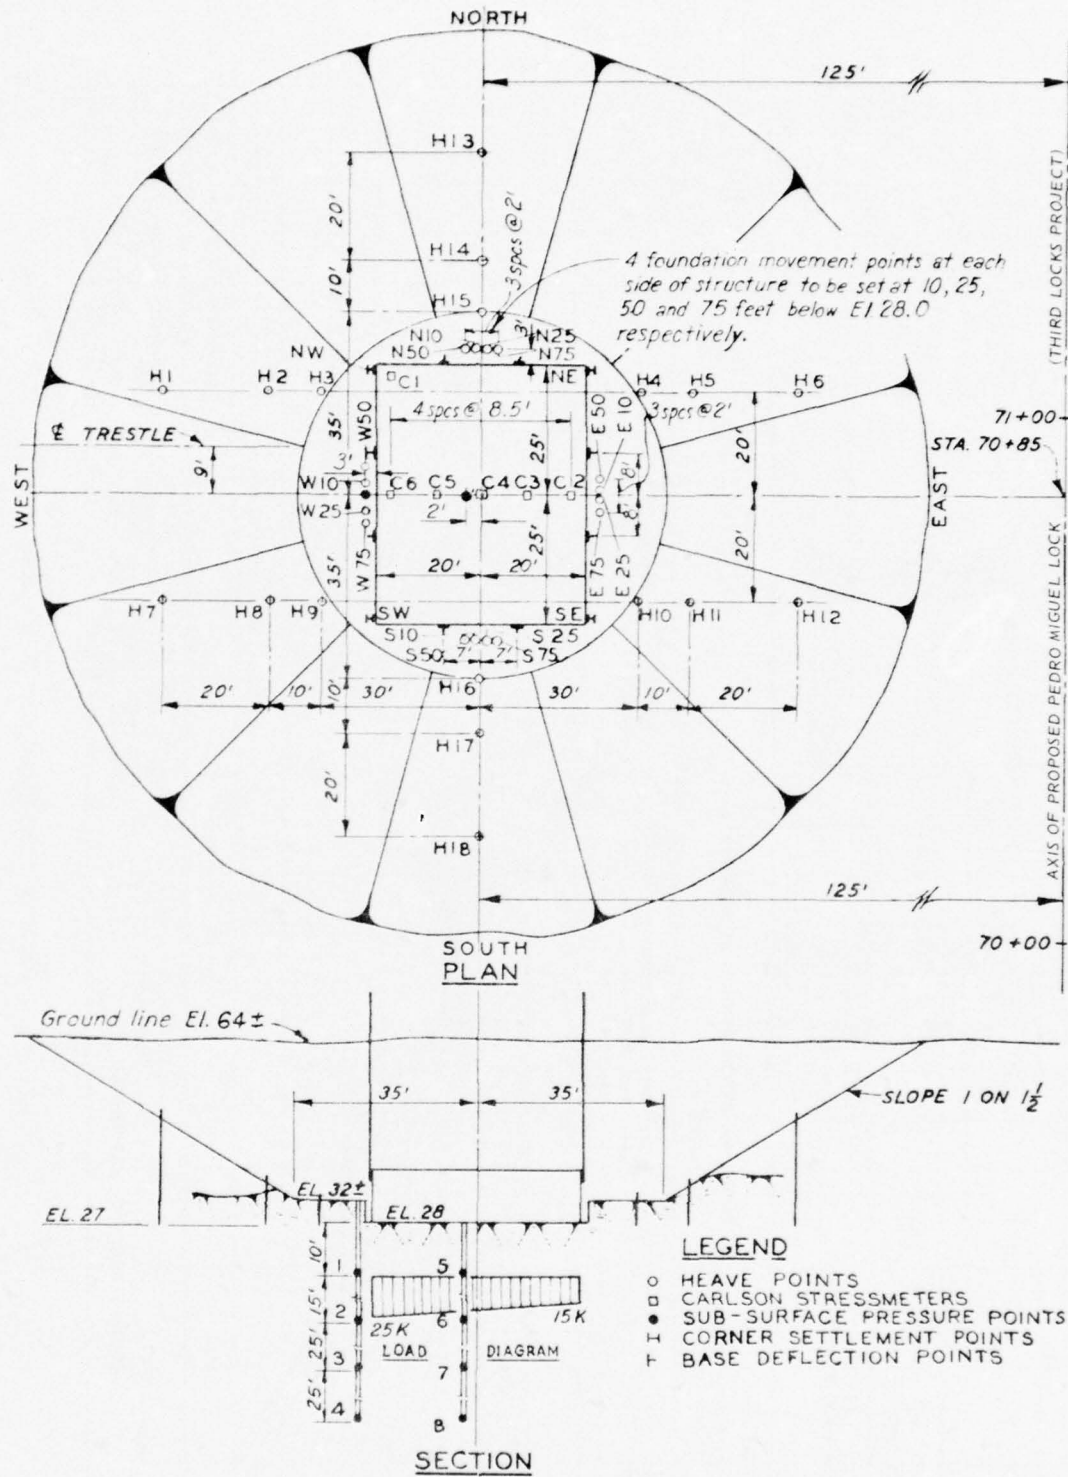
Fig. 30. Foundation plan and cross section with instrumentation locations

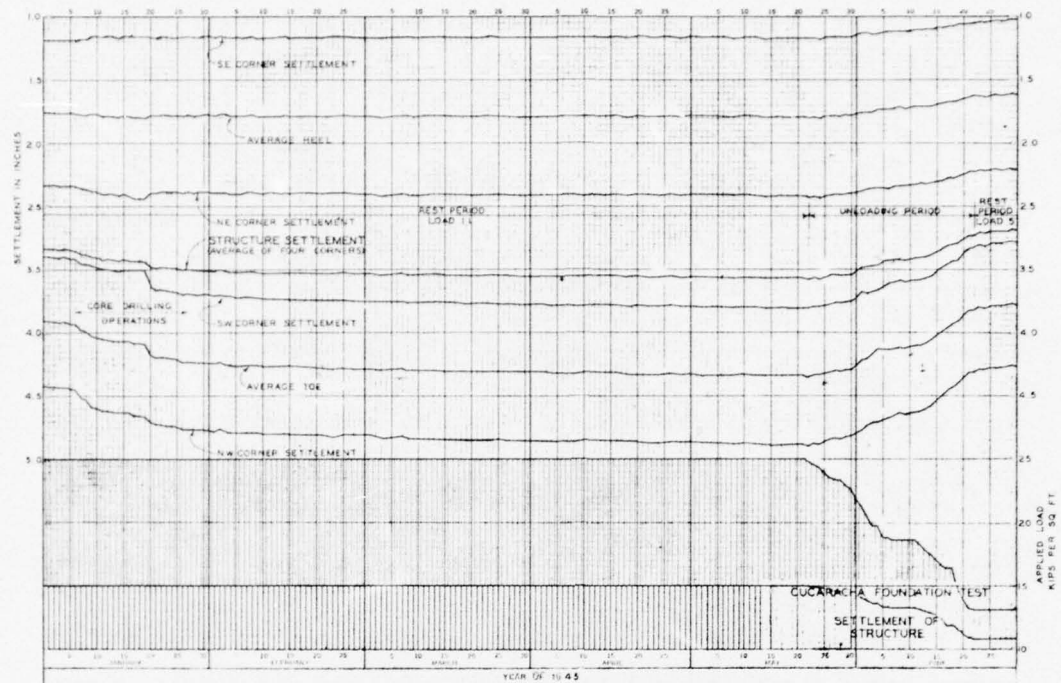
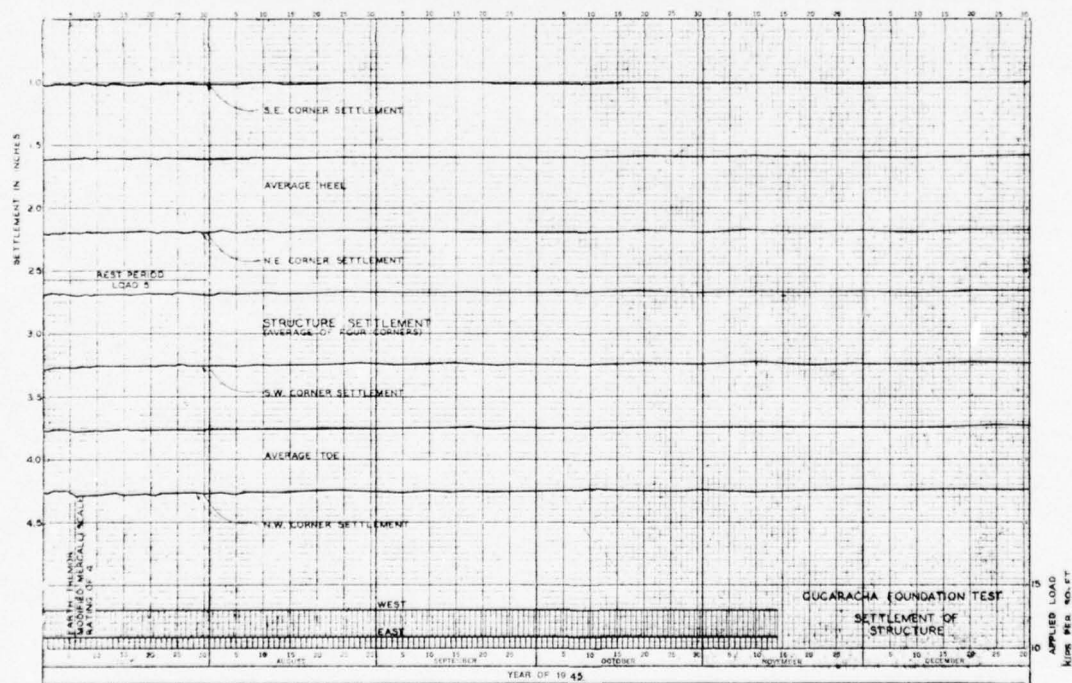
Fig. 33. Settlement of test structure during 1945

84. The summary of the settlement data that follows is based on the average settlement of all four corners of the test structure. An arbitrary distinction was made between "immediate" settlement, that occurring at the time of load application, and "intermediate" settlement, that occurring during rest periods. Significant data of the test are summarized in tables 5 and 6. Settlement versus time and load versus time curves for the test are shown in figs. 32-34. A semilog plot of settlement versus time for the load 5 rest period is shown in fig. 35. The uplift test during this rest period with the omission of 13 days of the uplift test from the curve made it difficult to decide if the settlement was complete at the end of the 113-day rest period. Semilog plots of settlement versus time for the rest periods of loads 6-11 are shown in fig. 35. During rest period 11, drilling operations at the site caused an abnormal settlement rate to occur between the 19th and 41st days of the rest period. This abnormal settlement has been omitted on the plot shown in fig. 36.

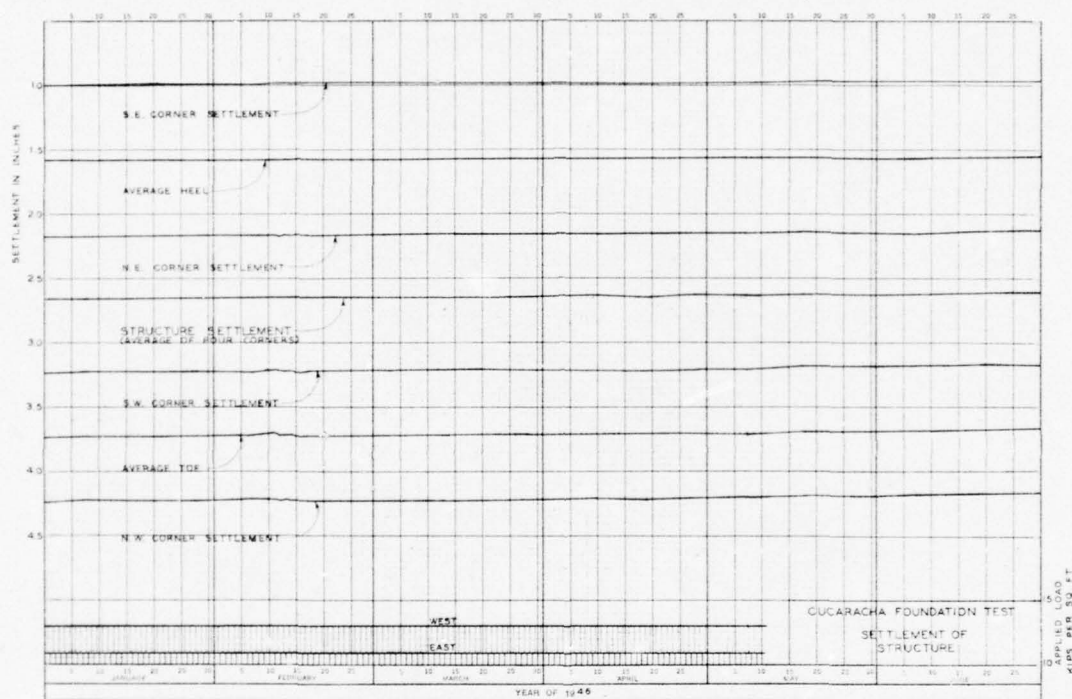
Fig. 34. Settlement of test structure, January-May 1946

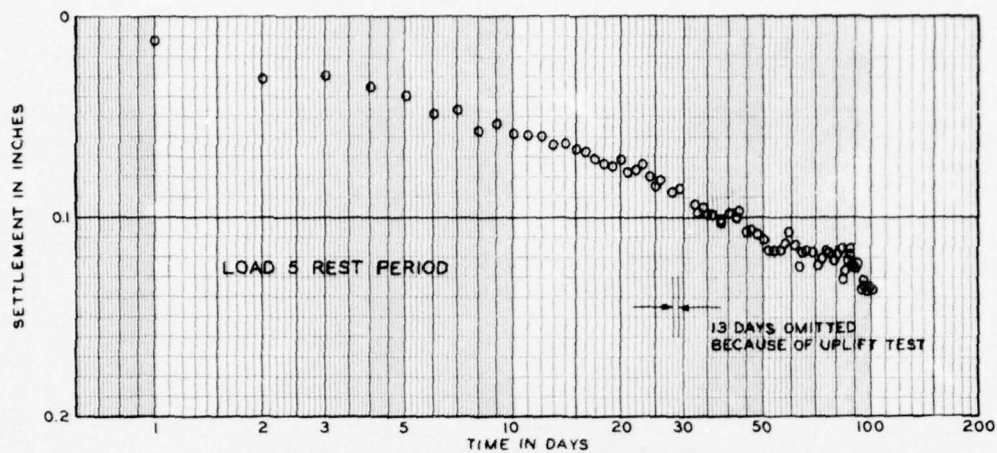
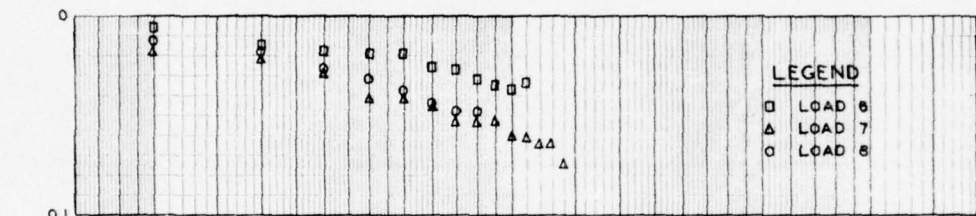
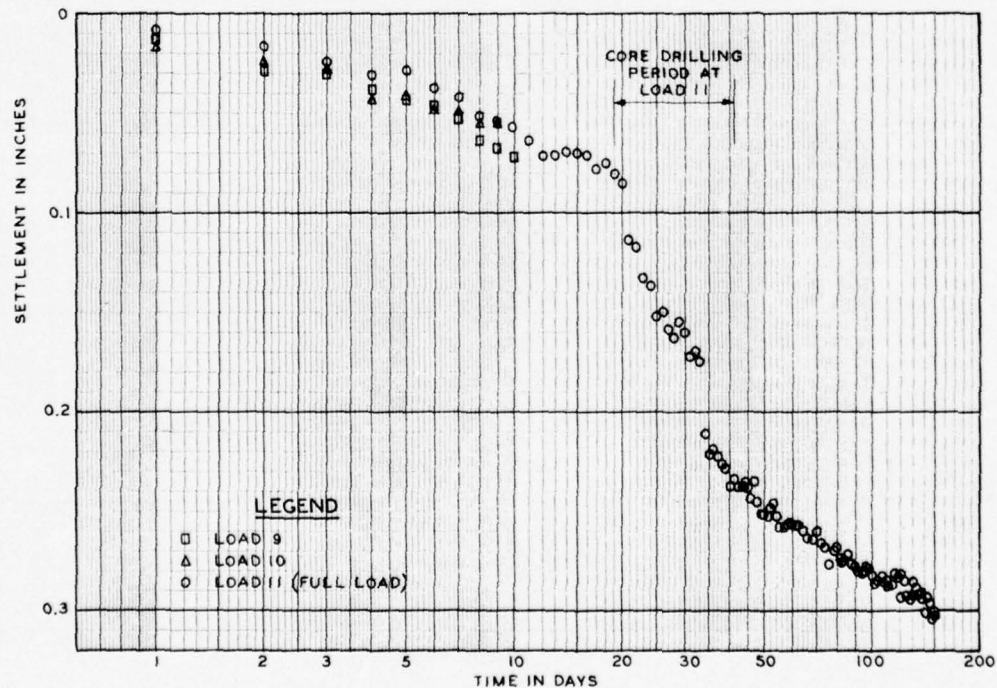
Fig. 35. Time-settlement curves for loads 5-11

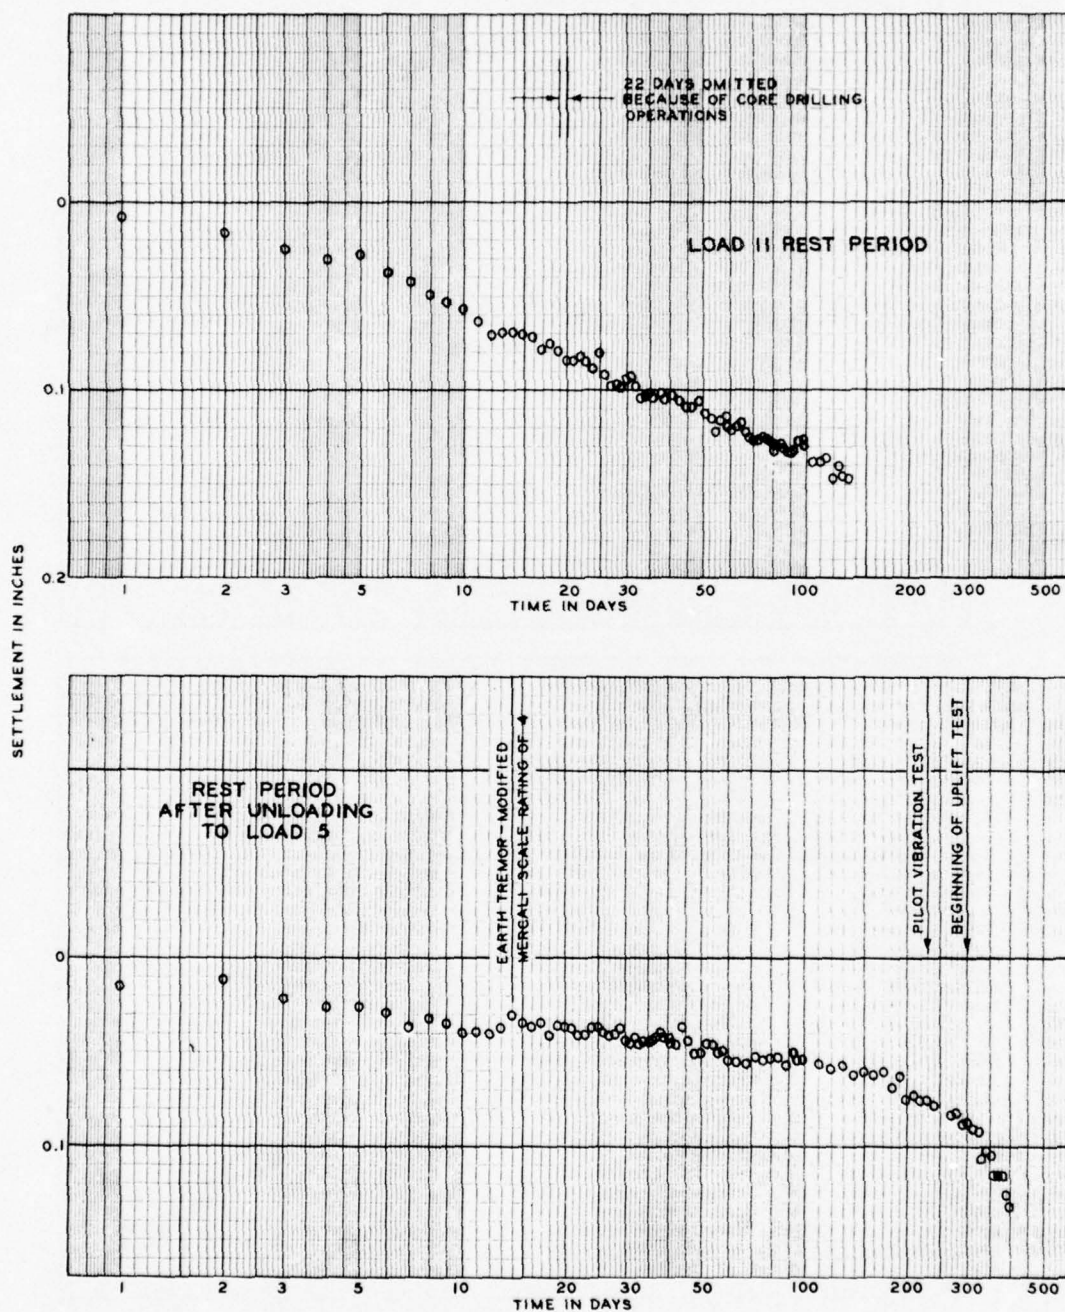
Fig. 36. Time-settlement curve for load 11 rest period and rebound after unloading to load 5

85. When the structure was unloaded to an average base load of 12 ksf, a 300-day rest period followed to observe long-time rebound characteristics. Observed rebound data have been plotted on a semilog scale in fig. 36. The rebound was only 32.2 percent of the observed settlement under the same load. The test loading during rebound was held constant for a period approximately twice as long as the earlier settlement rest period.

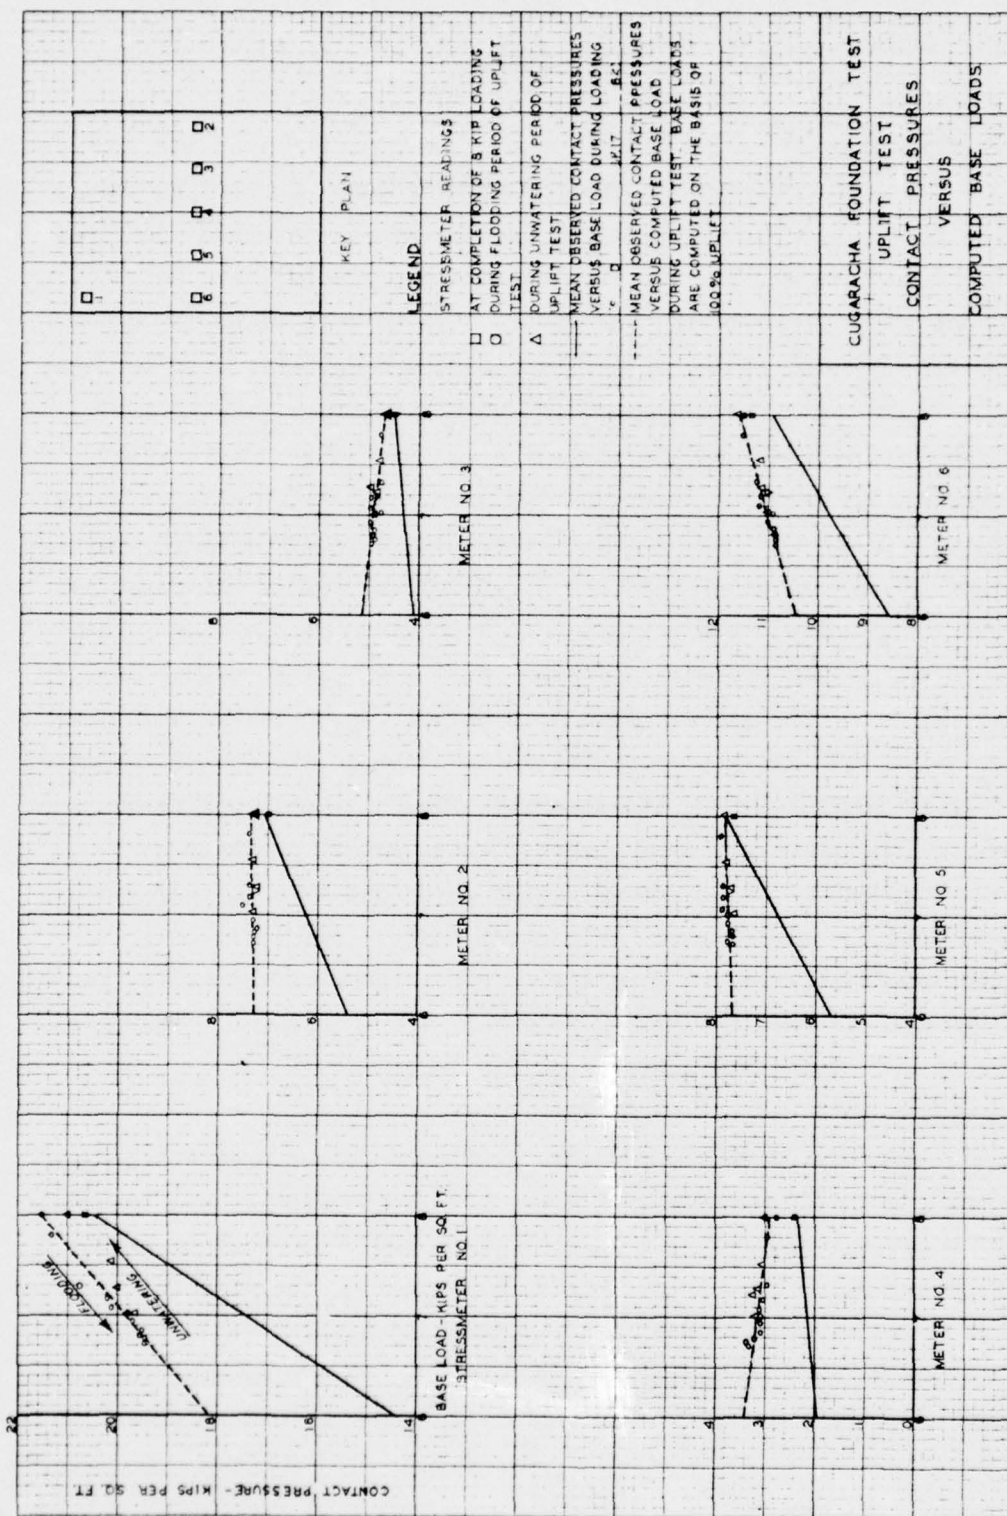
Fig. 37. Contact pressures versus computed base loads

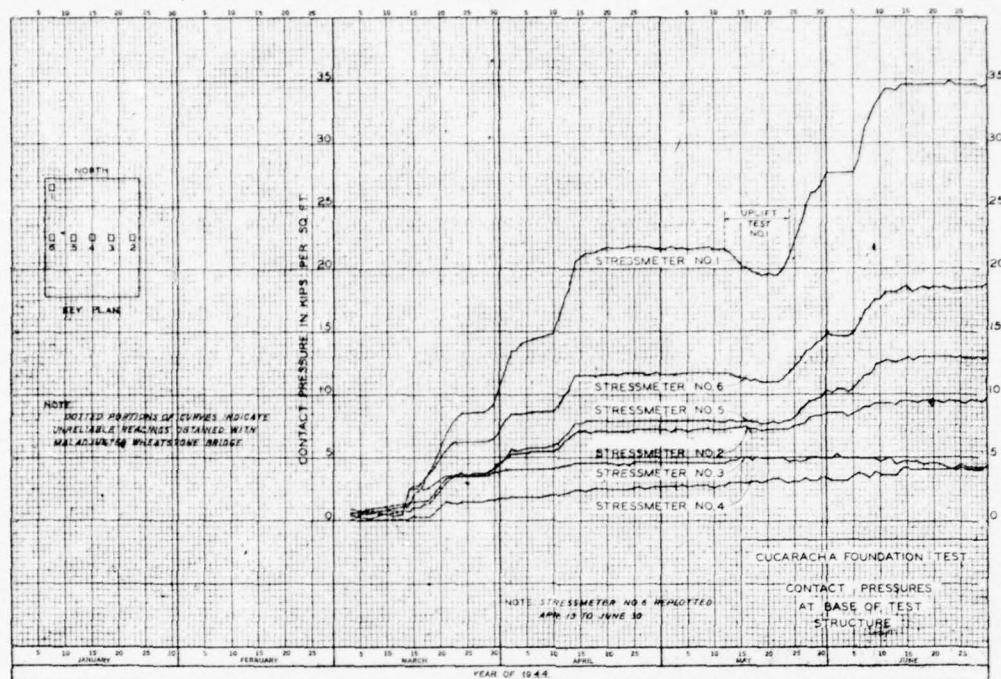
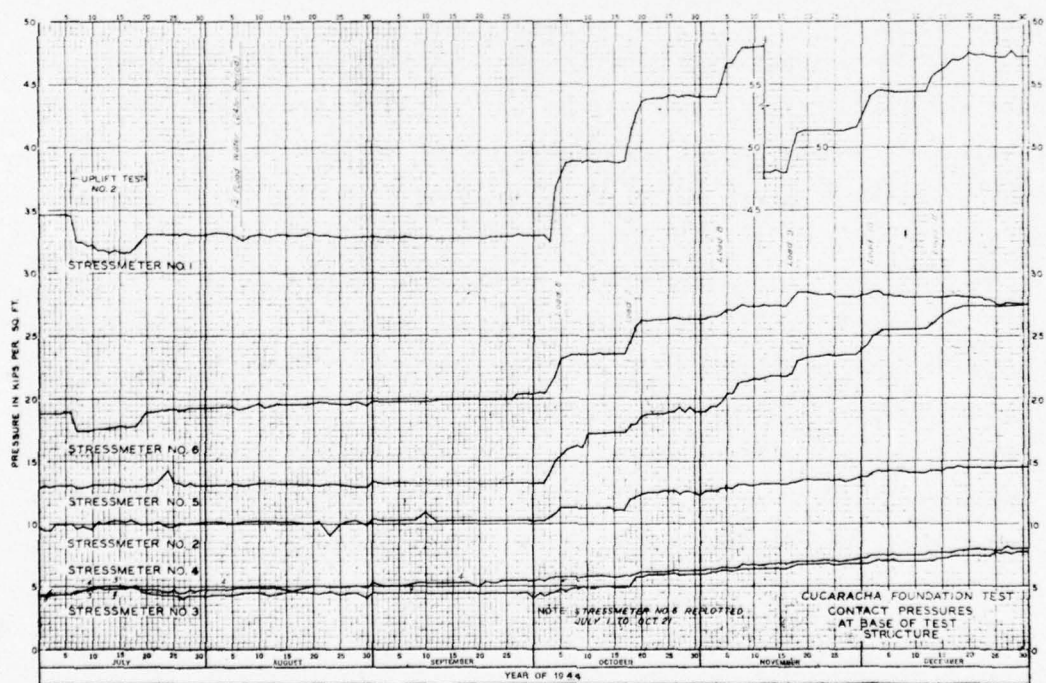
Fig. 38. Contact pressures at base of test structure during 1944
